MULTICHIP CERAMIC PACKAGE 28

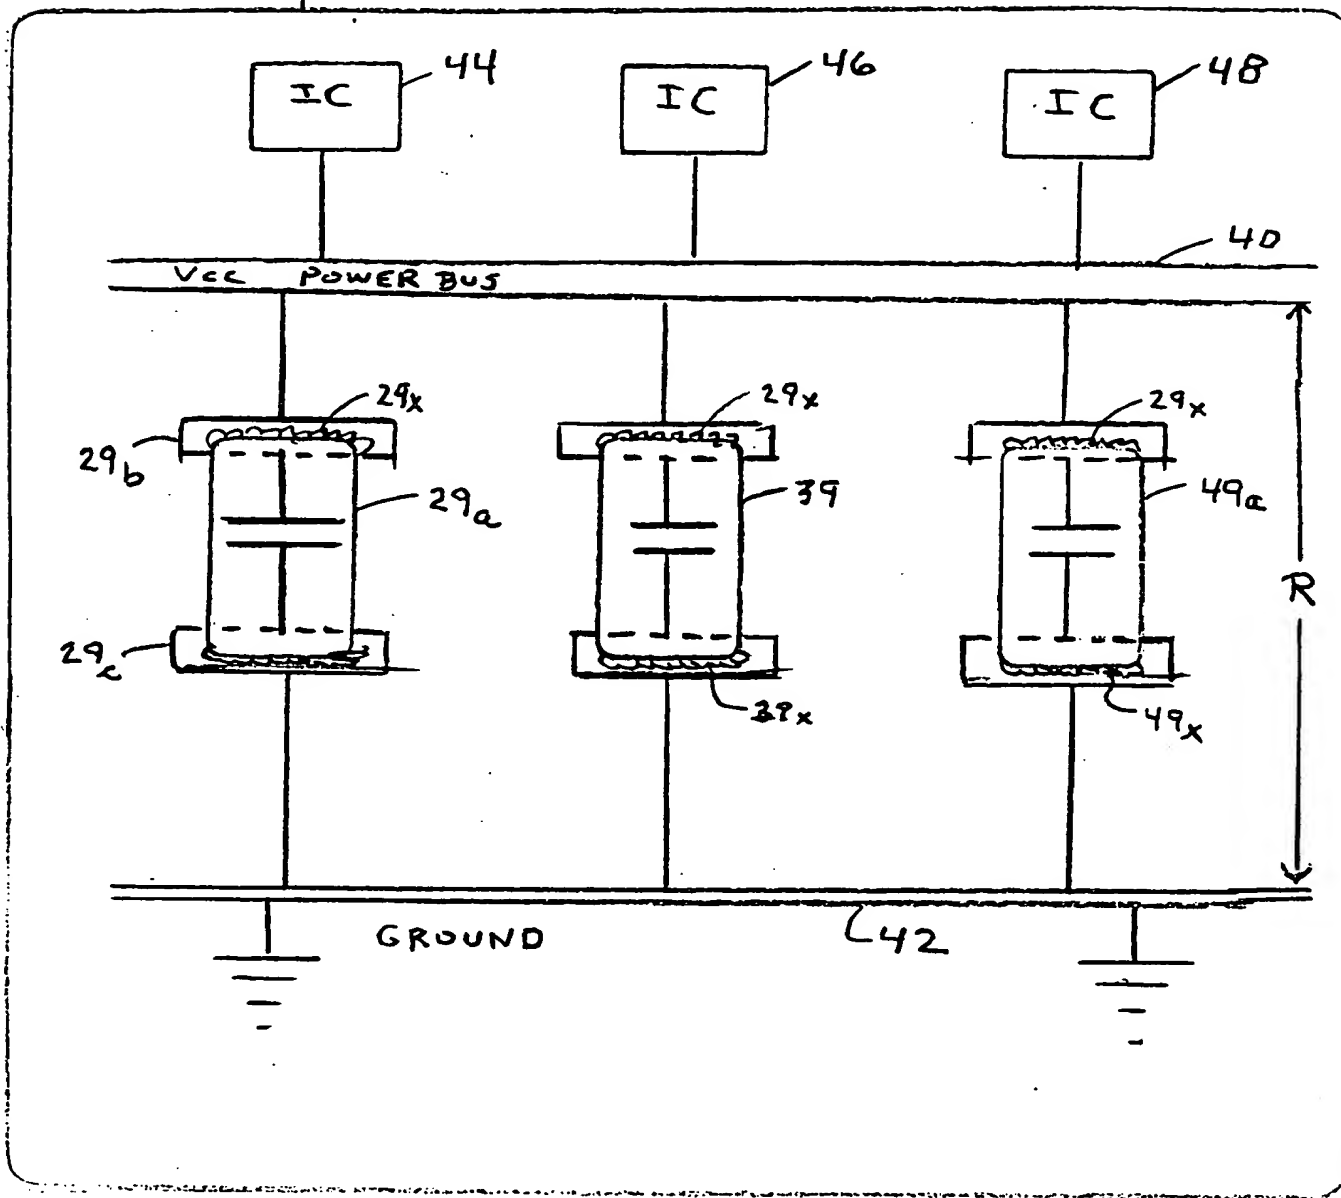
FIG. 2B

R = measured
resistance
during temperature
ramp-up and ramp-down

Defective part with intermittent short (W1008)

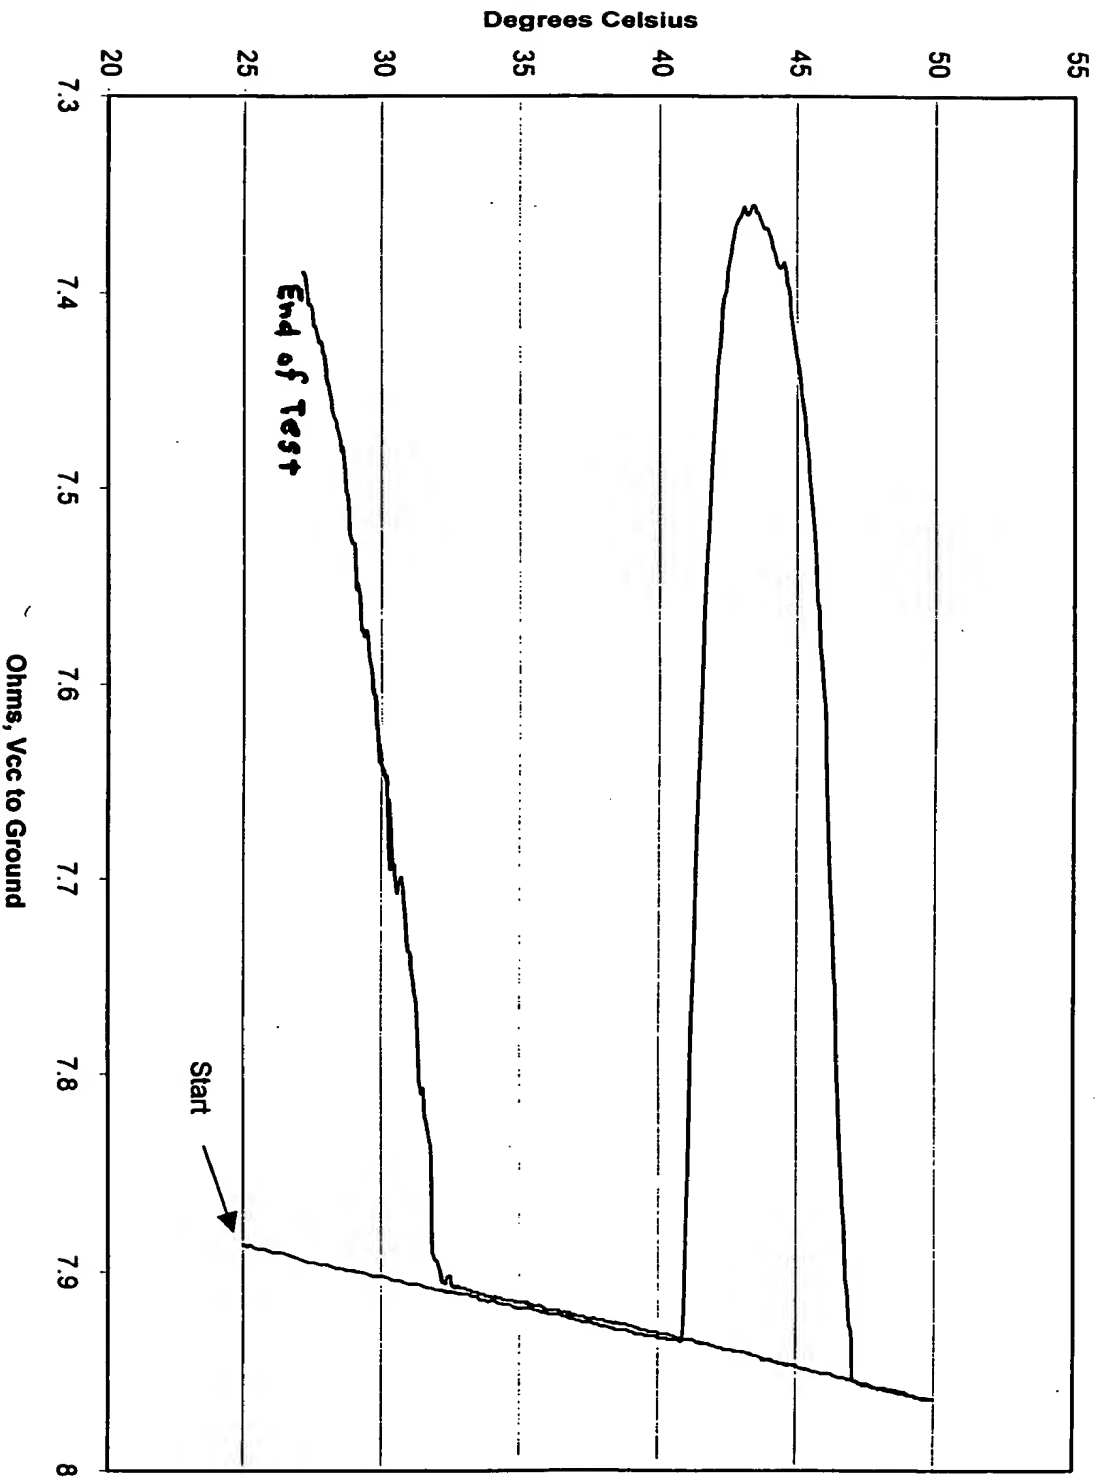
FIG. 3A
DKT 481-R3

Part W1008 after removal of short
